Lessons Learnt From the 2009 Padang Indonesia, 2011 Tohoku Japan and 2016 Muisne Ecuador Earthquakes

Article in *Frontiers in Built Environment* · June 2019

This paper presents the observations during the UK Earthquake Engineering Field Investigation Team (EEFIT)'s post-earthquake reconnaissance missions to the September 20, 2009 Padang (M_w 7.6), March 11, 2011 Tōhoku (M_w 9.0) and April 16, 2016 Muisne (M_w 7.8) earthquakes. The performance of buildings and geotechnical structures within the affected regions were investigated to gain insights on their design and construction deficiencies. Findings on these damages observed are compared along with the characteristics of the earthquake and nature of building codes in these countries. They include building damages attributed to a combination of structural resonance, deficiencies in reinforcement detailing, vulnerability to soft story collapse, ground settlement, soil liquefaction, and landslides. It was demonstrated that buildings which were severely damaged had natural building frequencies coinciding with the dominant frequencies of the ground shaking. The locations of damage of several such buildings showed insufficient confinin

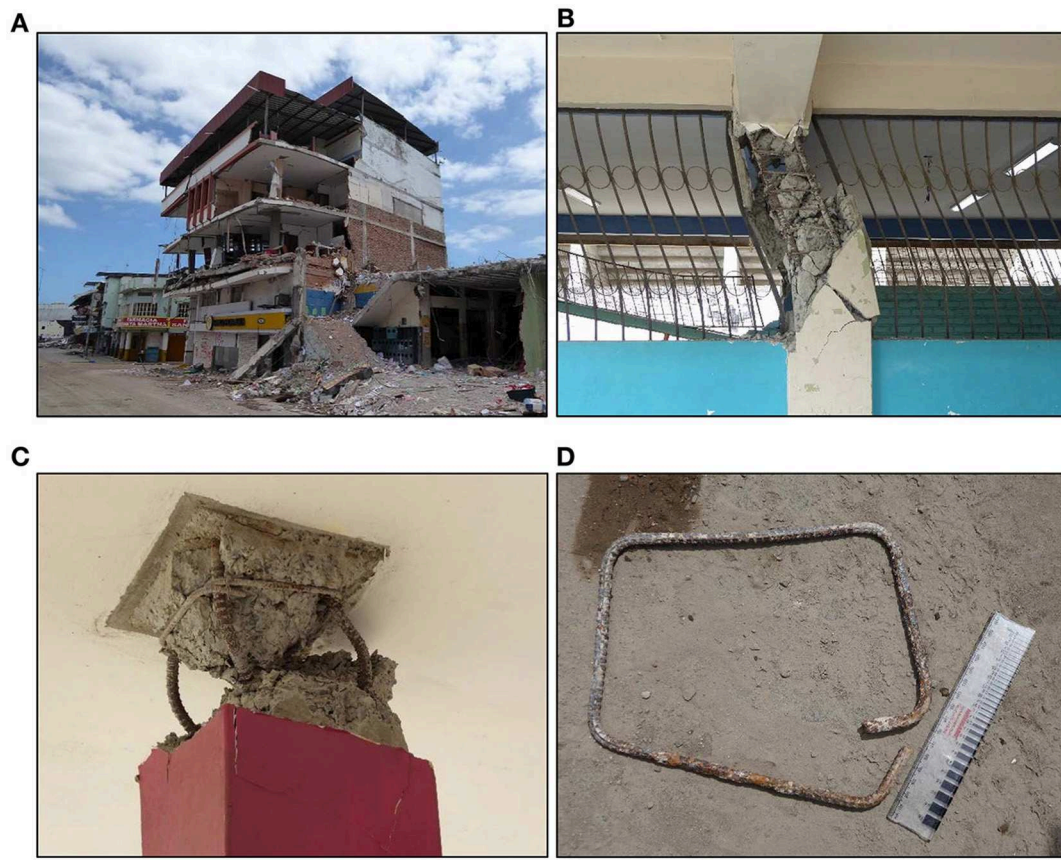
observed in several buildings (see **Figure 7A**). Column failure due to insufficient and poor shear design and detailing were also observed, some with poor lapping of link without 135° bend (see **Figures 7B–D**). There were also occasions where concrete cover was insufficient or missing (0–20 mm), which led to corrosion to the steel.

FIGURE 7 | Failures caused by inadequate design of infills and reinforcement detailing following the Muisne earthquake. **(A)** inadequate design/detailing of RC frame and infills at Portoviejo. **(B)** School building with short column failure at Pedernales. **(C)** Column head failure showing insufficient shear design at Portoviejo. **(D)** insufficient lapping of column link with no 135°-bend at Manta.

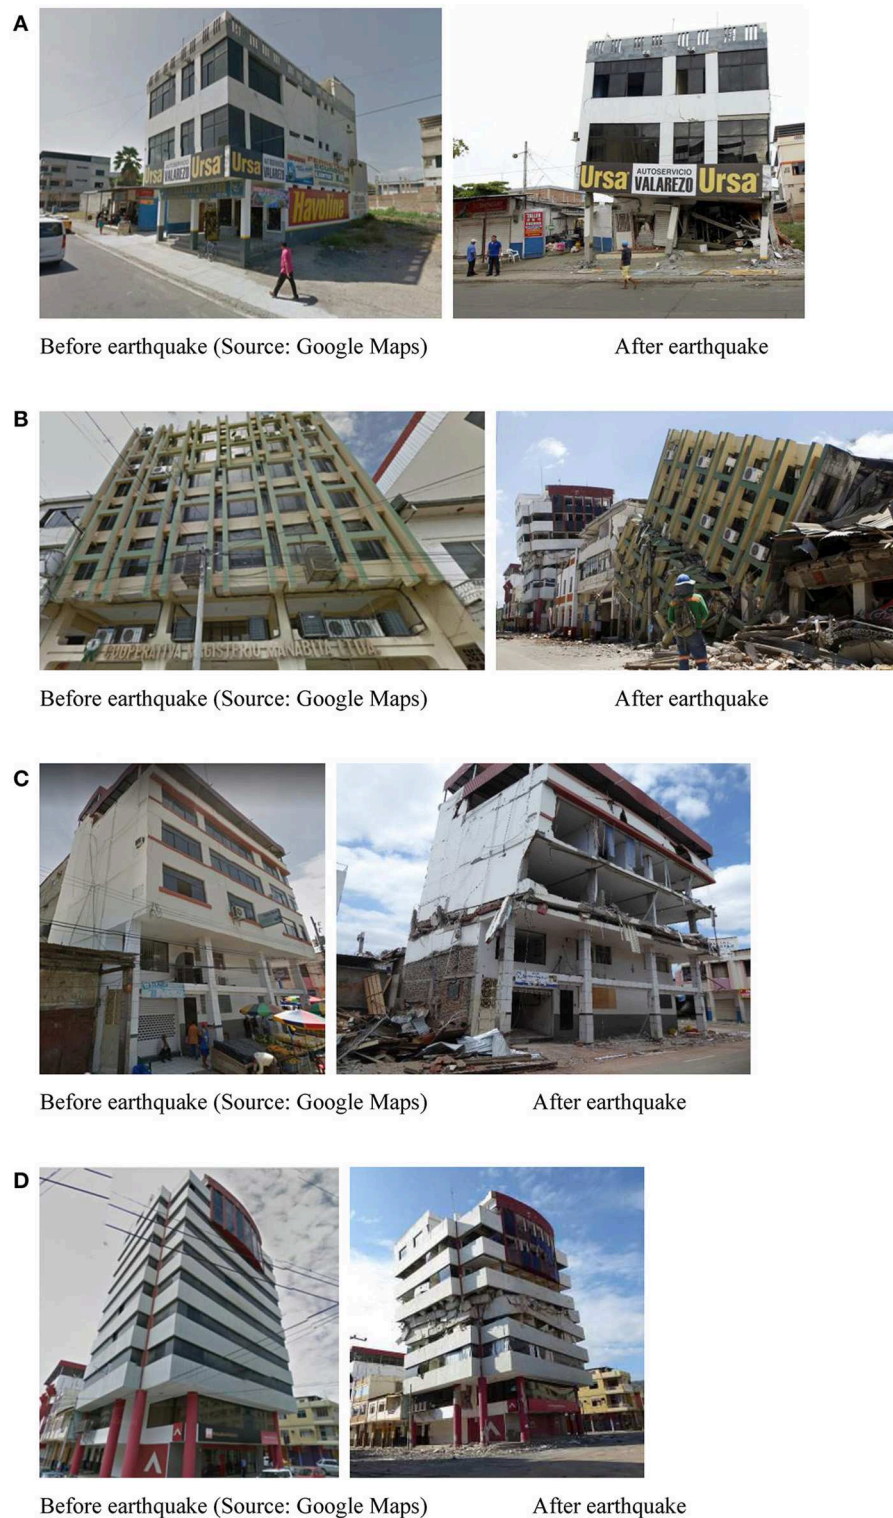
Most seismic induced soft-story collapse failures occur particularly at the ground level where there exist columns with minimal infill walls or simply due to higher loadings transferred from upper stories. Such typical soft-story failures, alike to those observed at Padang and Tōhoku, were observed as shown in **Figure 8A**. However, in contrast, there were also observations of upper floor soft-story failures in a number of buildings following this Muisne earthquake. Change in stiffness of the story or plan was one of the key factors leading to such occurrence of upper-story collapses. Examples include the Magistrate building and a commercial building in Portoviejo and Manta, respectively, where discontinuity of stiffness was observed, as shown in **Figures 8B,C**. There were however occasions where upper soft-story collapse occurred on buildings without obvious change in structural stiffness, plan or story height (e.g., **Figure 8D**). Further investigation appeared to confirm that such failure could be due to extension of the building long after the bottom floors

FIGURE 8 | Soft story collapse following the Muisne earthquakes. **(A)** soft story collapse at ground level of car garage at Manta. **(B)** Upper story collapse at the Magistrate building at Potoviejo due to change in stiffness at 1st floor. **(C)** Upper story collapse at commercial building at Manta due to change in stiffness at 2nd floor. **(D)** Upper story collapse at Mutualista Pichincha building in Portoviejo.

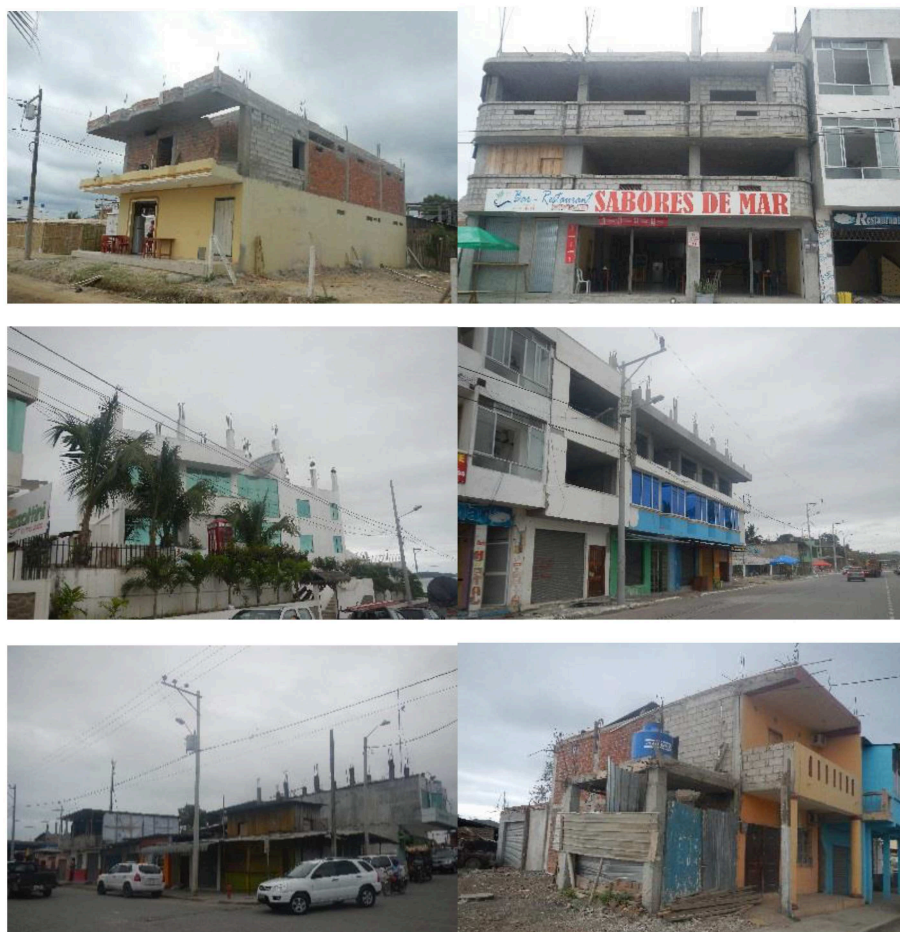
were completed. Such practice appears to be rather prevalent in these towns (see **Figure 9**), although several other countries do have similar practices such as the *Beşkats* in Turkey and in Greece. The joints between new and old were typically poorly executed with insufficient lapping of the rebar, resulting in weak and brittle connection with local reduction in capacity, hence promoting failure in these areas. Such findings are alike to failures observed in post-earthquake reconnaissance to Turkey and Greece (Earthquake Engineering Field Investigation Team (EEFIT), 2003; Pomonis et al., 2011). In addition, the reinforcement bars often left out for many years can experience surface corrosion, which weaken their bond to the new concrete during casting. Such localized upper-story damage may also be attributed to all rebar being lapped at one height, resulting from the use of the same length bars in all columns. The increased axial loads would also cause more severe problems for the bottom floors.

FIGURE 9 | Exposed reinforcement for future extension of building observed in various affected towns in Ecuador.

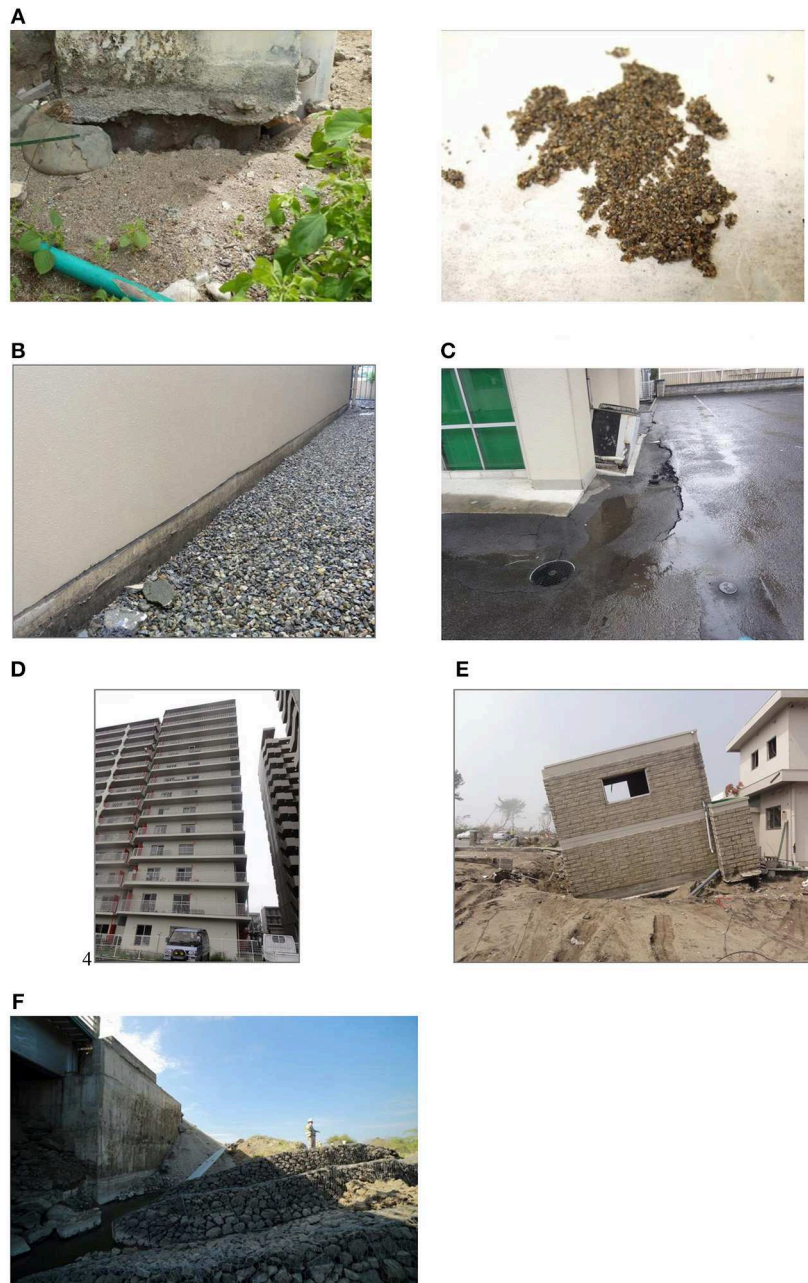
Following the 2009 Padang earthquake, observations of foundation failures were minimal with foundations of buildings mostly intact with some minor settlement in the region. One of the university buildings in Universitas Negeri Padang with pile foundation had suffered slight differential settlements. This led to cracks and settlements of non-suspended slabs in one of the adjoining classrooms. The pile foundations were found on deep stiffer soil, which did not settle as excessively as the surrounding ground. Therefore support to key structural members such as columns and beams performed well with minimal structural damage. **Figure 12A** illustrates the settlement of the surrounding soil of about 100 mm relative to the pile foundation. Coarse sand deposits were found in this area.

(**Figure 12B**). Foundations of a handful of lower rise buildings of expectedly shallower foundation penetration depth sank relative to the surrounding ground level (**Figure 12C**). Other attributing factors could be due to soil liquefaction as evident with occurrence of sand boils and ground settlement measuring as much as 70 mm nearby. In the affected areas, ground settlement caused tilting of high rise buildings (**Figure 12D**) and affected the use of external staircases and roadways leading to carparks. In some cases, differential settlement rendered apartment buildings unsuitable for occupancy and had to be demolished. Overturning of buildings due to impact of the tsunami mainly occurred to buildings with shallow foundation or slender piles. Soil liquefaction can allow piles to be pulled out of the soil more easily. Scouring due to fast-flowing tsunami waves around buildings also reduces ground bearing support which led to tilting of buildings as shown in **Figure 12E**. Coastal subsidence of more than 0.5 m in numerous coastal towns and cities also caused these shorelines to suffer frequent tidal flooding.

foundation suffered excessive settlement and lateral spreading at the southern road entrance of the bridge. The location of bridge was along the narrow channel of young sediment deposit extending northwest to Crucita based on the geological map. Ground settlements of up to 1.1 m and lateral spreading as much as 3 m of the road embankment were observed. At the time of the survey, the surface of the approaches had been repaired, although sizeable settlement and rotation of the gabions on the river bank on the south west side of the bridge were observed (see **Figure 12F**). Heavy rain and flooding in the region during the days leading up to the earthquake could have raised the ground water table level, making ground more susceptible to liquefaction.

FIGURE 12 | Foundation and ground failures following Padang, Tohoku and Muisne earthquakes. **(A)** Settlement of ground around column where sand was found in the proximity. **(B)** Ground settlement around building at Sendai. **(C)** Sinking of building relative to surrounding at Sendai. **(D)** building tilt due to differential settlement at Sendai. **(E)** loss of soil bearing due to scour at sendai. **(F)** settlement and rotation of gabions on the river bank Mejia bridge.

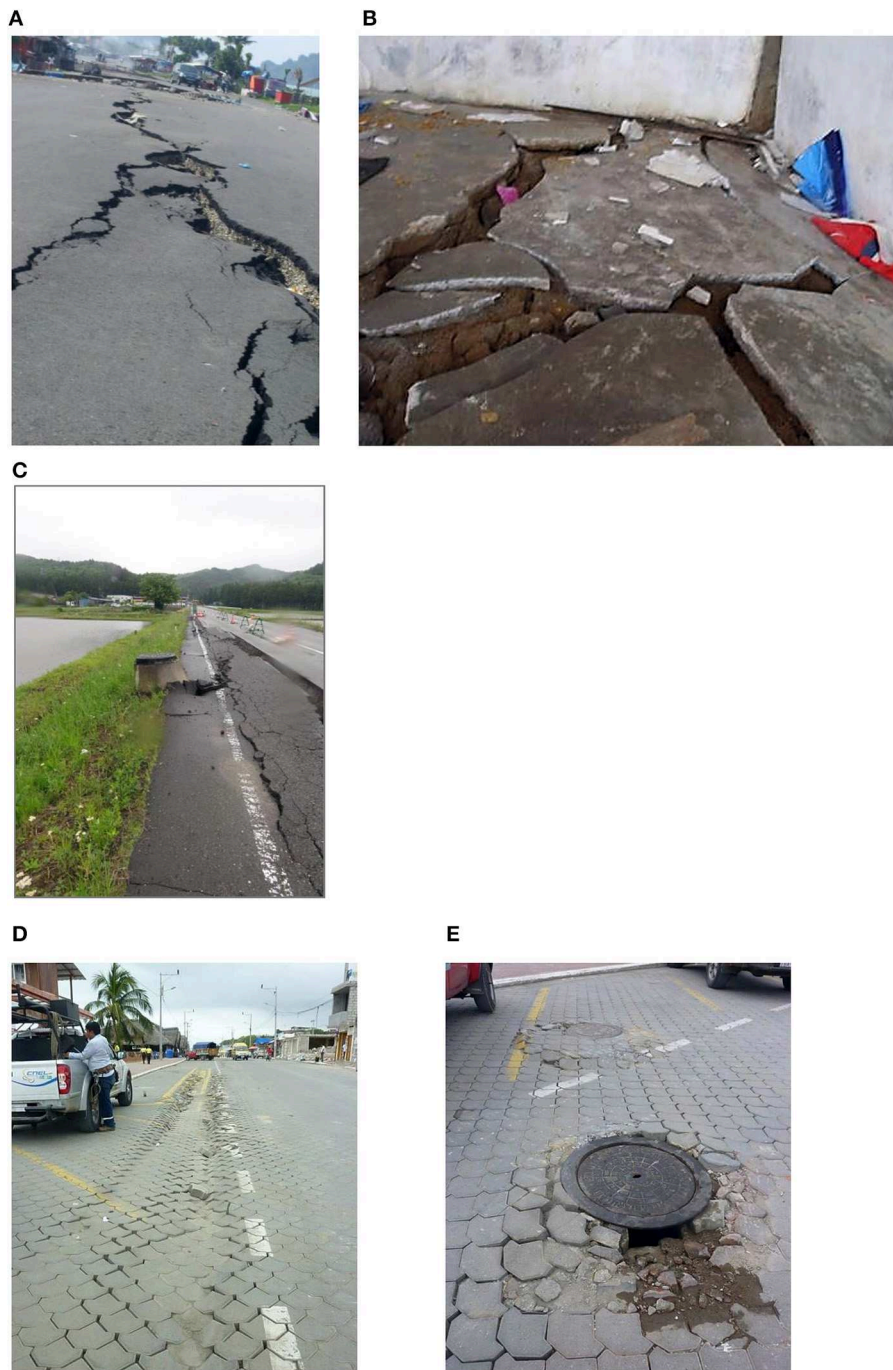
coastal strip plain. The tension cracks on the road and near the beach were the consequence of lateral spreading as portrayed in **Figure 13A**. Landwards into the Padang city center, the Mere Amelie Church suffered effects of liquefaction as well. Sand boils were observed in the school beside the church (Yayasan Prayoga SD Agnes). These sand boils were predominantly silty sand which came from the soil deep beneath the topsoil. In low-lying land regions, clear signs of liquefaction were also sighted as evident from a well in Siteba Village which had been choked by the rising sand due to the build-up of pore water pressure during the earthquake. The excavated soil was investigated and found to be uniformly graded fine sand, confirming liquefaction susceptibility. In nearby Perumdam Village, two adjacent single-story houses near the river had suffered from the effects of liquefaction. Excess pore water pressure had built up below suspended floor slabs, leading to the upheaval of the slabs as shown in **Figure 13B**. Once the cracks in the floor slabs had opened, the water could flow out, thus relieving the excess pore pressure and allowing the floor slabs to settle back.

In Japan following the Tōhoku earthquake, liquefaction induced uplift of manholes and lateral spreading were also observed in Shirakawa and Sendai (**Figure 13C**). In Ecuador, evidence of earthquake-induced soil liquefaction, such as ground settlement and uplift of underground pipes and manholes, was observed at several locations visited in the Manabí province. Along the seafont in Pedernales, settlements of 100 mm were observed on interlocking block pavements (**Figure 13D**) with manholes protruding by some 30 mm (**Figure 13E**). The former was attributed to the compaction of loose soil deposits under strong

FIGURE 13 | Consequence of soil liquefaction following the Padang, Tohoku, and Muisne earthquakes. **(A)** Tension cracks arising from lateral spreading at Padang city. **(B)** upheaval of floor slabs of village house due to liquefaction at Perumdam Village, Padang. **(C)** Uplift of manhole and lateral spreading at Shirakawa. **(D)** ground settlement on pavement at Pedernales. **(E)** uplift of manhole close to the observe ground settlement at Pedemales.

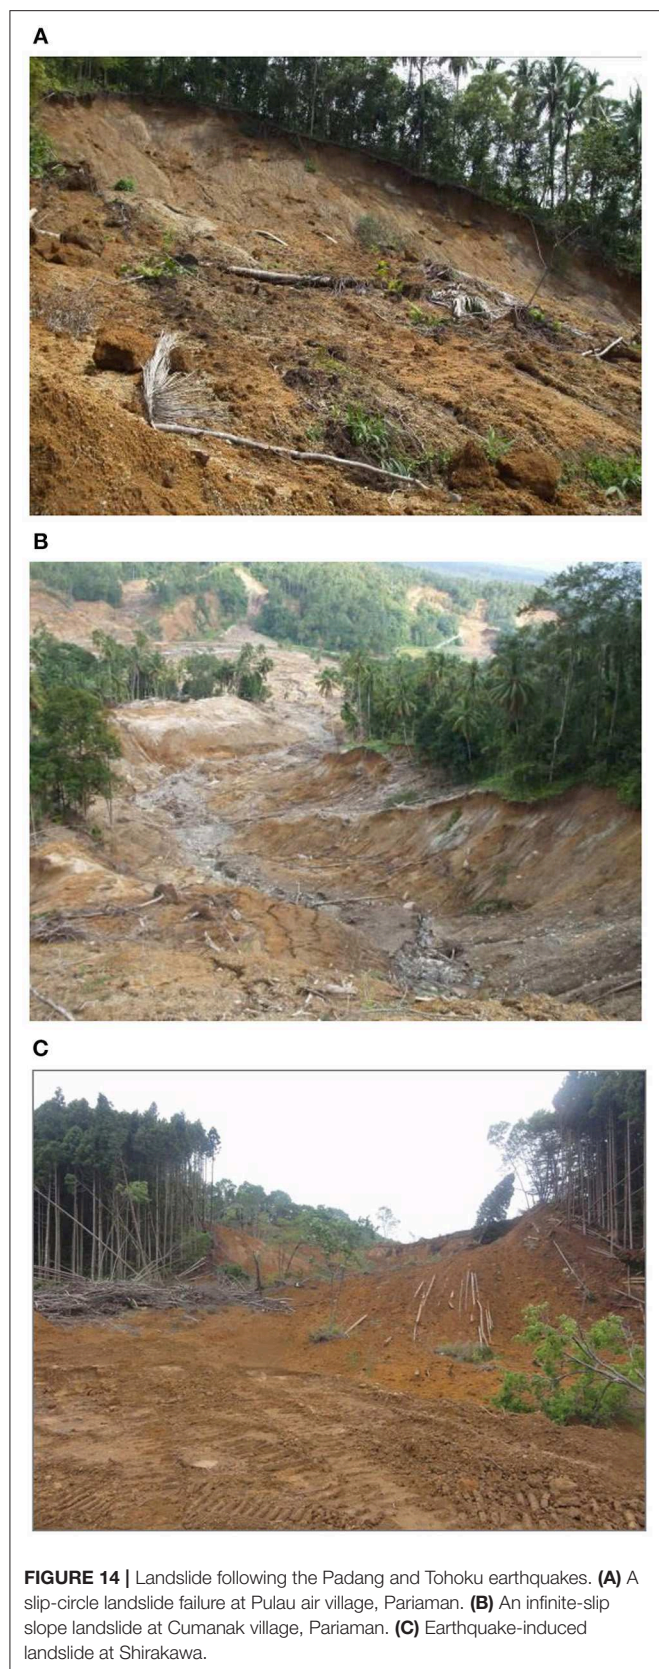
Landslides at Padang were widespread in the mountainous topography landwards of Pariaman. **Figures 14A,B** show two of the several landslide sites visited in the worst-affected district of Nagari Tandikek in Pariaman. Two villages, Pulau

FIGURE 14 | Landslide following the Padang and Tohoku earthquakes. **(A)** A slip-circle landslide failure at Pulau air village, Pariaman. **(B)** An infinite-slip slope landslide at Cumanak village, Pariaman. **(C)** Earthquake-induced landslide at Shirakawa.

and houses at the foot of slopes, resulting in traffic disruption, property losses and 13 casualties in Shirakawa as shown in **Figure 14C**. In Ecuador, numerous landslides were observed along the coast between San Vicente and Canoa, where the Northern Bahia Fault is mapped. These slope instabilities, also present along the southern coastal cliffs close to Bahia and in many places in the estuary, were attributed to excavation of steep slopes for road construction. The San Isidro section of the Canaveral Fault may also have aggravated the damage in the region following the earthquake. Other contributing factors leading to greater severity of slope instability include: (1) greater saturation of water in soil due to heavy rainfalls leading up to the time of earthquake, (2) lateral spreading from liquefaction of soft alluvial soil layers causing slippage at weak interfaces near the surface of slope, (3) lack of stabilization at man-made cut slopes, (4) river bank management leading to increased stream velocities which loosen or erode earth embankments, and (5) flood plains next to vulnerable man-made slopes (e.g., Portoviejo).
